Alert Technology - Domestic Case Study

Project Overview

Property Type - Domestic Property, build date 1938

Scope of Works - Major refurbishment

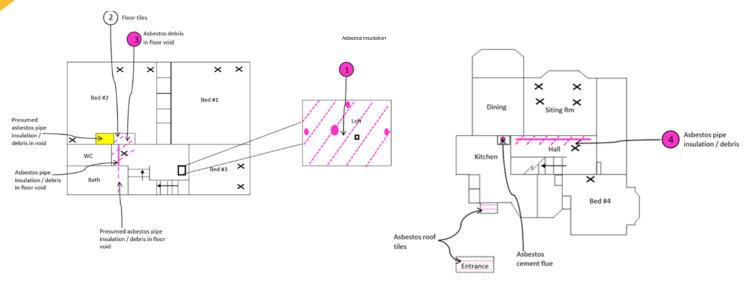
Location of the Asbestos

First	X004	Landing	Pipe insulation in floor void	Remove under controlled conditions by approved contractor
First	X004	Landing	Debris in floor void	Remove under controlled conditions by approved contractor
First	Presumed	Void adjacent Water Pump Cupboard	Pipe insulation / debris	Remove under controlled conditions by approved contractor
First	Presumed	Bathroom	Pipe insulation / debris	Remove under controlled conditions by approved contractor
Ground	004	Entrance Hall	Pipe insulation / debris	Remove under controlled conditions by approved contractor
Ground	Visual	Kitchen	Cement flue above boiler	Remove under controlled conditions by approved contractor

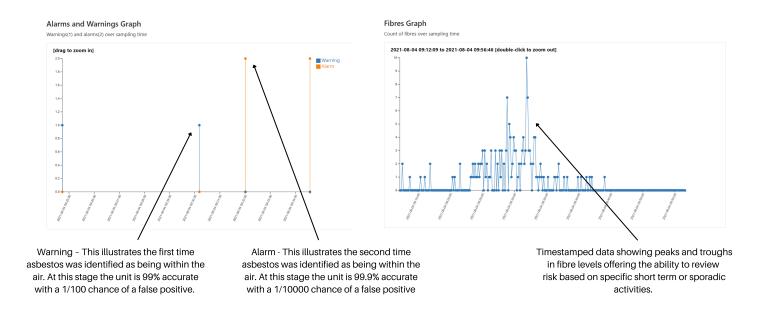
During the completion of the additional non-asbestos works, an Alert Pro1000 was positioned on-site to provide reassurance to the employees that the risk from asbestos was being monitored. On the first morning that works commenced following the completed asbestos removals, the Pro1000 alarm was sounded within 20 minutes of being on-site.

Please see below for the graphs that were developed based on the data collected by the unit:
