## Domestic Case Study

### Background

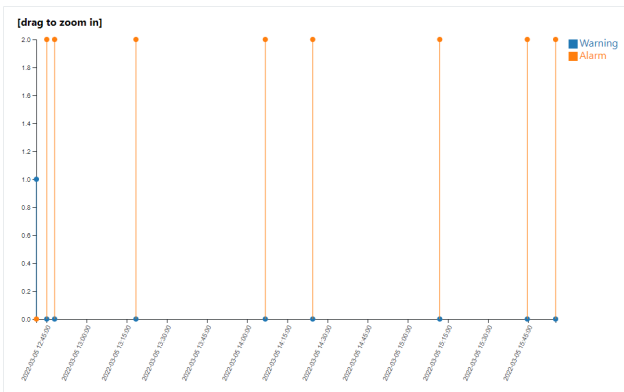
Graph 1 - Alarms

Graph 1 illustrates the number of times the alarm was triggered during the sampling session. As you can see the alarm was raised multiple times.

The Pro1000 uses light scattering and fibre re-orientation technology to identify airborne asbestos. Each time the alarm is sounded, there is a 99.8% confidence of asbestos being in the air.

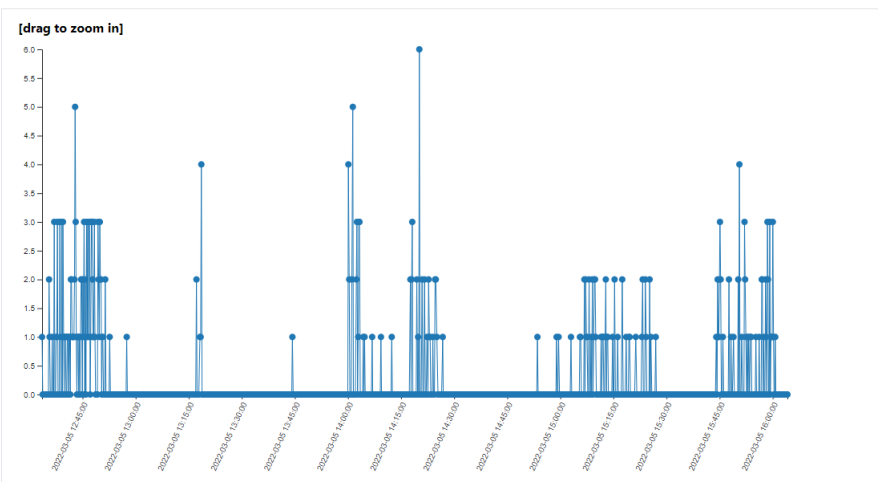
Graph 2 - Fibres

Graph 2 visually illustrates the fibre levels throughout the sampling session. All data is timestamped to enable the thorough review of the data. The peaks and troughs are visible throughout the session and provide the opportunity to identify the specific activity that lead to asbestos being disturbed.
